**Community Environmental Response  
Facilitation Act (CERFA) Report**

**Hamilton Army Airfield  
Novato, California**

**U.S. ARMY ENVIRONMENTAL CENTER  
ABERDEEN PROVING GROUND, MARYLAND 21010**

**April 1994**

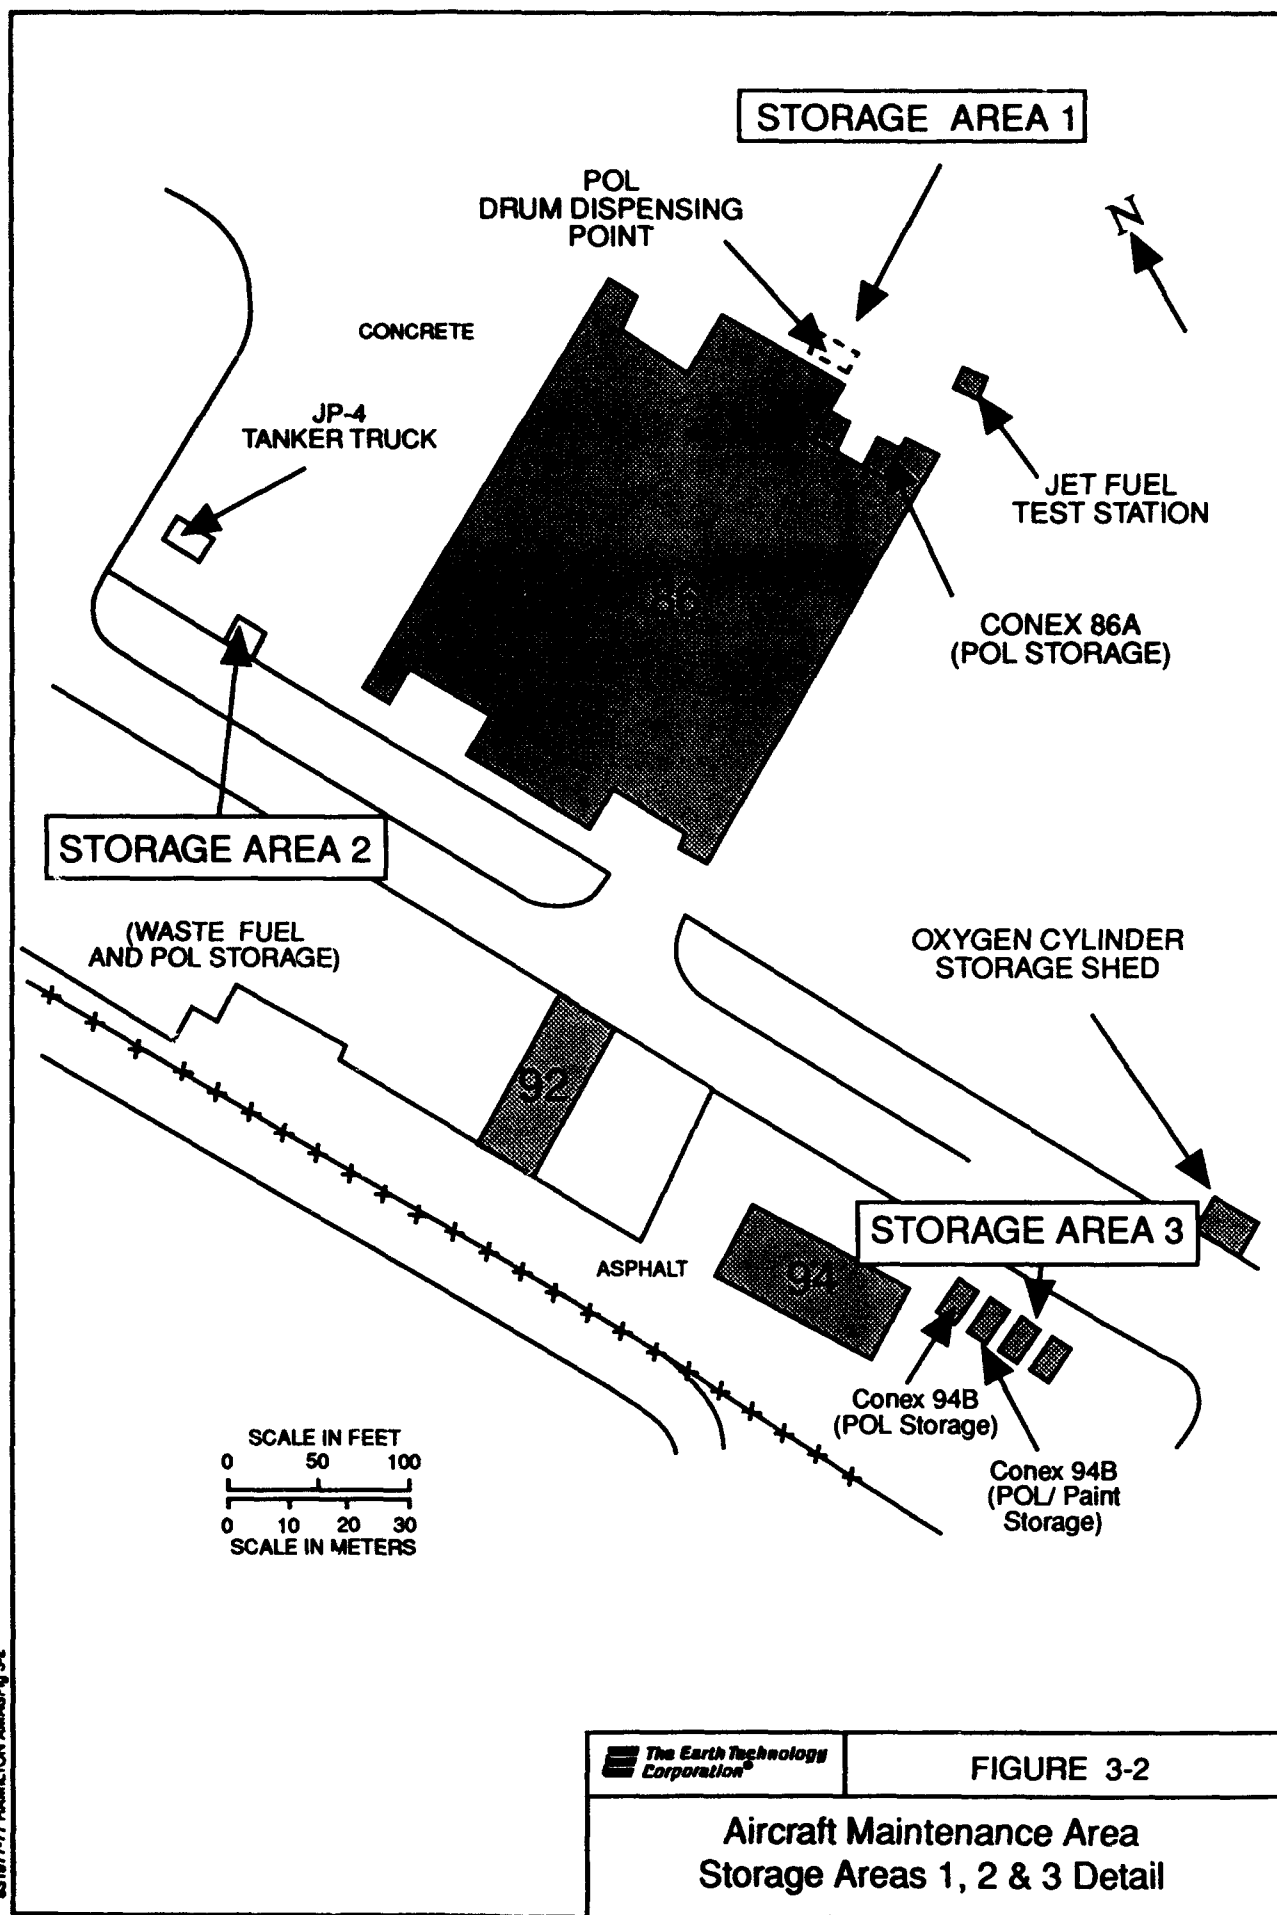
FIGURE 3-1

# Aircraft Maintenance Storage Area Locations

**Aircraft Maintenance Area:** The Enhanced PA identified the handling and storage of oils, fuels, and other aircraft-related liquids as potential contamination sources in the Aircraft Maintenance Area. The various hazardous substance and POL storage areas in the aircraft maintenance area are shown in Figures 3-1, 3-2, and 3-3 (see Section 3.1.2). The Enhanced PA recommended that soil samples should be collected from north of Building 87, east of Building 87 and at Storage Area 2. Sediment samples were recommended for the storm sewer located within and surrounding the maintenance building. The Enhanced PA also recommended that a groundwater well be placed immediately downgradient of Storage Area 3. During the environmental investigation, 3 monitoring wells, 6 soil borings, 2 test pits, and 7 storm sediment sample points were installed; semivolatile organic compounds and lead were detected in drain sediments. Maximum concentrations were 425 mg/kg semivolatile organic compounds and 690 mg/kg lead. Sediment samples were also collected from the south drainage ditch storm sewer outfall. Samples exhibited elevated concentrations of TPH (1,230 mg/kg), semivolatile organic compounds (17.9 mg/kg), and lead (168 mg/kg).
